**Hygrothermal and Freeze-Thaw  
Assessment of 5 Brickwork Replica  
Panels**

**Compton Buildings Ltd**

**Date: 15<sup>th</sup> October 2007**

**CBT Reference: BT07614TAS / BT07638TAS**

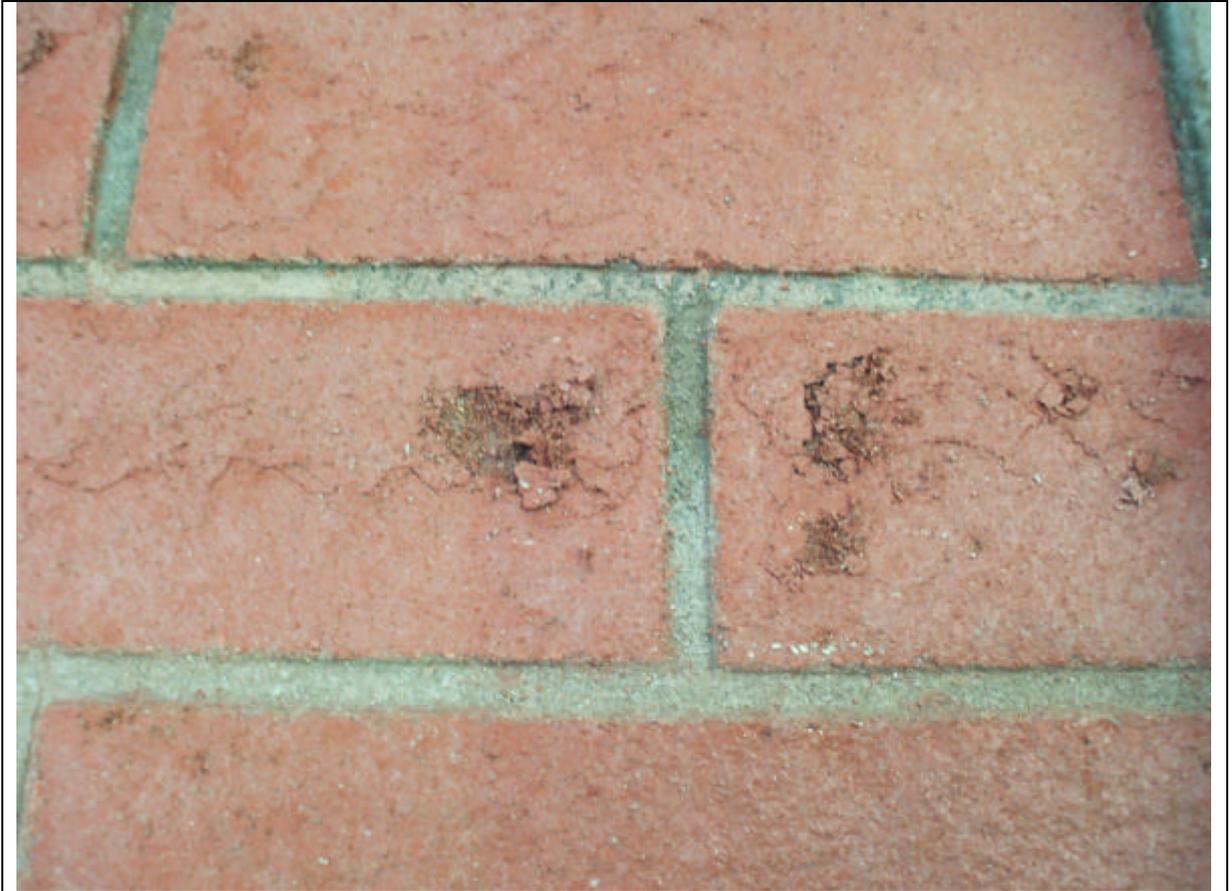
Inspection of the 5 panels following the 100 cycles identified that only the Plywood Panel showed any significant signs of deterioration following the exposure. The damage incurred

is best described as a “crumbling” of the upper pigmented layer of the render. This had become soft and spongy to touch, and if gently rubbed would disintegrate.

Based on the results of the testing, it is clear that the different exposure conditions have had different effects on the panels to different degrees. The only panel to show any significant damage following exposure was the Plywood Panel following Freeze-Thaw exposure. The upper layer of the 2 coat render system, in this case the pigmented layer, was adversely affected by the freeze-thaw action. The surface layer became soft, spongy and very friable. On the basis that this panel had only received 10 days curing prior to testing rather than the +28 days for Panels A-D. On this basis only partial hydration of the cement phases will have been completed prior to the first frost cycle, thus limiting the initial strength of the top layer of the render.

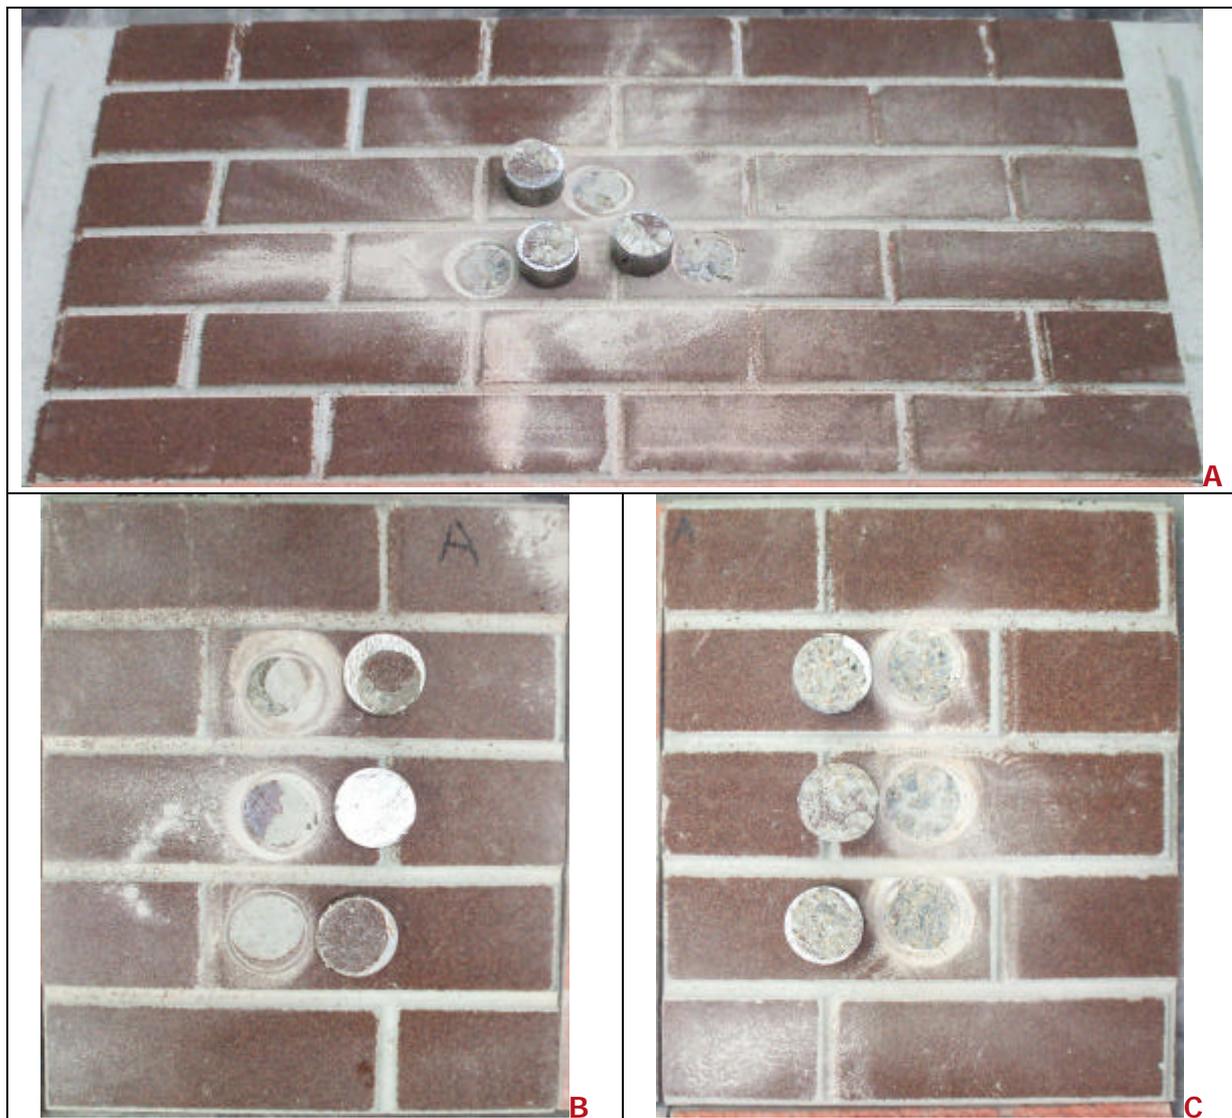
**Panel A**

Panel A Control	$F_u$ (N)	$f_u$ (N/mm <sup>2</sup> )	Fracture Pattern
1	3031	1.54	25% base 75% surface
2	3061	1.56	60% base 40% surface
3	2658	1.35	80% base 20% surface
<b>Mean</b>	<b>2917</b>	<b>1.49</b>	<b>55% base 45% surface</b>

Panel A HP	$F_u$ (N)	$f_u$ (N/mm <sup>2</sup> )	Fracture Pattern
1	1819	0.93	50% base 50% surface
2	1126	0.57	60% base 40% surface
3	1202	0.61	10% base 90% surface
<b>Mean</b>	<b>1382</b>	<b>0.75</b>	<b>40% base 60% surface</b>

Panel A F/T	$F_u$ (N)	$f_u$ (N/mm <sup>2</sup> )	Fracture Pattern
1	1549	0.79	100% failure in base
2	2284	1.16	100% failure in base
3	2499	1.27	100% failure in base
<b>Mean</b>	<b>2111</b>	<b>1.07</b>	<b>100% failure in base</b>

Pull Off Figures A – Control, B – After Hygrothermal Exposure, C – After Freeze/Thaw Exposure

Panel A, for testing purposes here, is regarded as a Control panel. This panel is based on the method of current manufacture and is simple the bonding of stained sand to the surface of the concrete base. The values for the pull offs deteriorated (reduced) following exposure to both weathering conditions. The hygrothermal exposure appears form the pull offs to have had the most significant effect of the weathering exposures. The pull off value

dropped to just under 50% of the starting value, for the freeze-thaw exposure panel the value dropped to just over 70% of the starting value. The mode of failure is different in both also, the hygrothermal panel failed by pulling the sand coating off the concrete, whereas the freeze-thaw panel failed within the surface layer of the base concrete. This tends to indicate that the wetting and heating cycled has somehow broken the bonding capacity to a degree of the adhesive between the sand and the concrete.

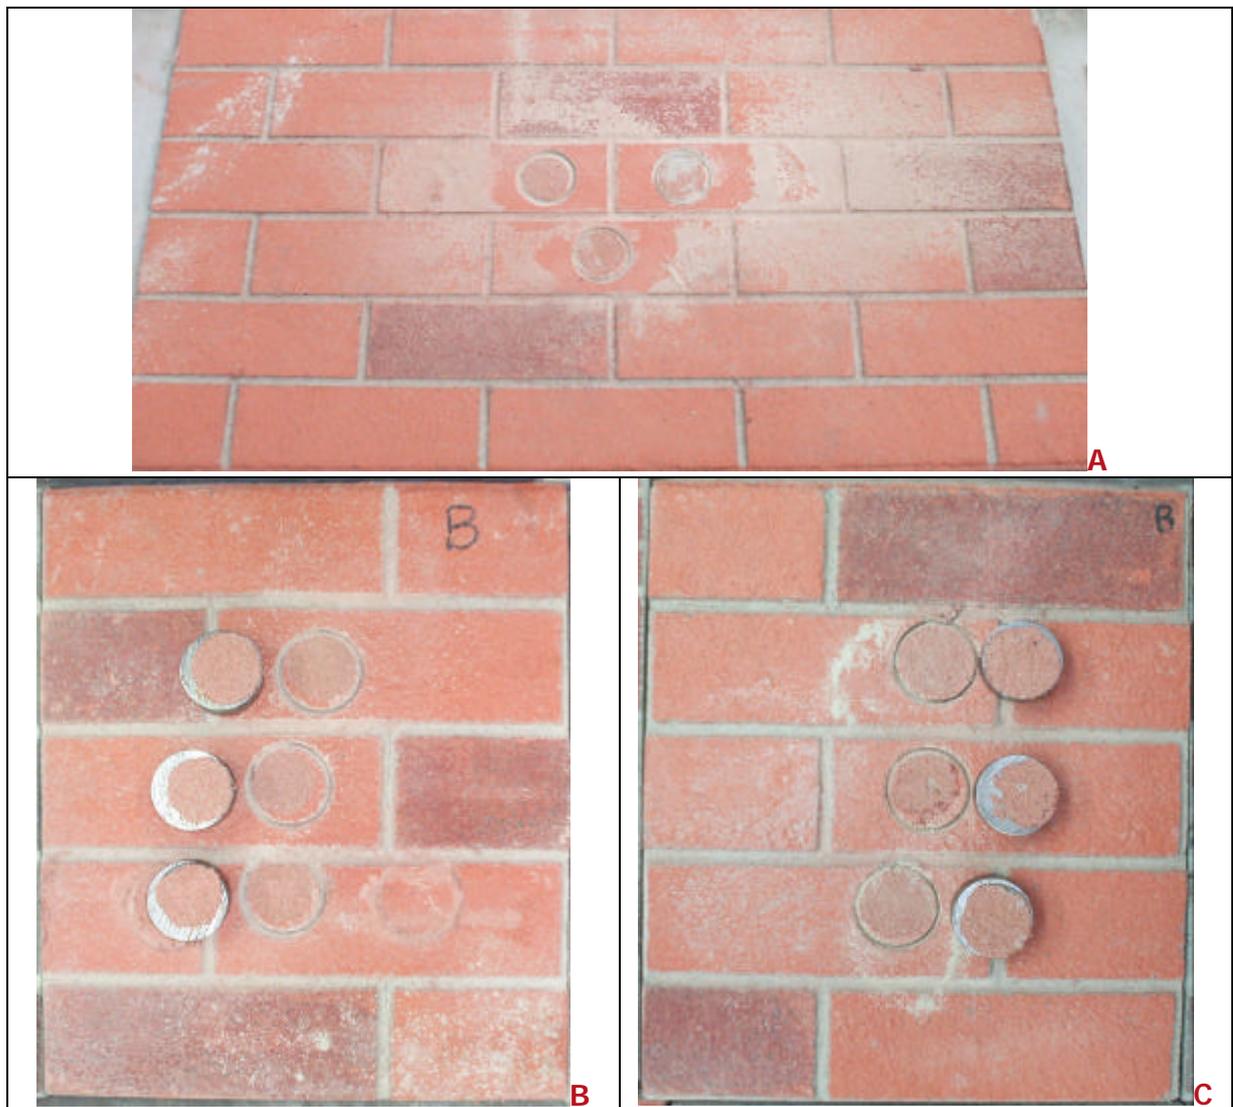
**Panel B**

Panel B Control	$F_u$ (N)	$f_u$ (N/mm <sup>2</sup> )	Fracture Pattern
1	2247	1.14	100% in pigmented layer
2	2693	1.37	100% in pigmented layer
3	2899	1.48	100% in pigmented layer
<b>Mean</b>	<b>2613</b>	<b>1.33</b>	<b>100% in pigmented layer</b>

Panel B HP	$F_u$ (N)	$f_u$ (N/mm <sup>2</sup> )	Fracture Pattern
1	1608	0.82	100% failure in pigmented layer
2	1646	0.84	100% failure in pigmented layer
3	2247	1.14	100% failure in pigmented layer
<b>Mean</b>	<b>1834</b>	<b>0.93</b>	<b>100% failure in pigmented layer</b>

Panel B F/T	$F_u$ (N)	$f_u$ (N/mm <sup>2</sup> )	Fracture Pattern
1	2231	1.14	100% failure in pigmented layer
2	1353	0.69	80% failure in pigmented layer
3	2560	1.30	100% failure in pigmented layer
<b>Mean</b>	<b>2048</b>	<b>1.04</b>	<b>+80% failure in pigmented layer</b>

Pull Off Figures A – Control, B – After Hygrothermal Exposure, C – After Freeze/Thaw Exposure

Pull off values for the hygrothermal panel were again reduced compared to the control panel. The value had reduced to about 70% of the original pull off force. The value for the freeze-thaw panel was also reduced to about 80% of the control value. In both cases the failure mode was similar to that of the control panel, with the failure being within the pigmented layer.

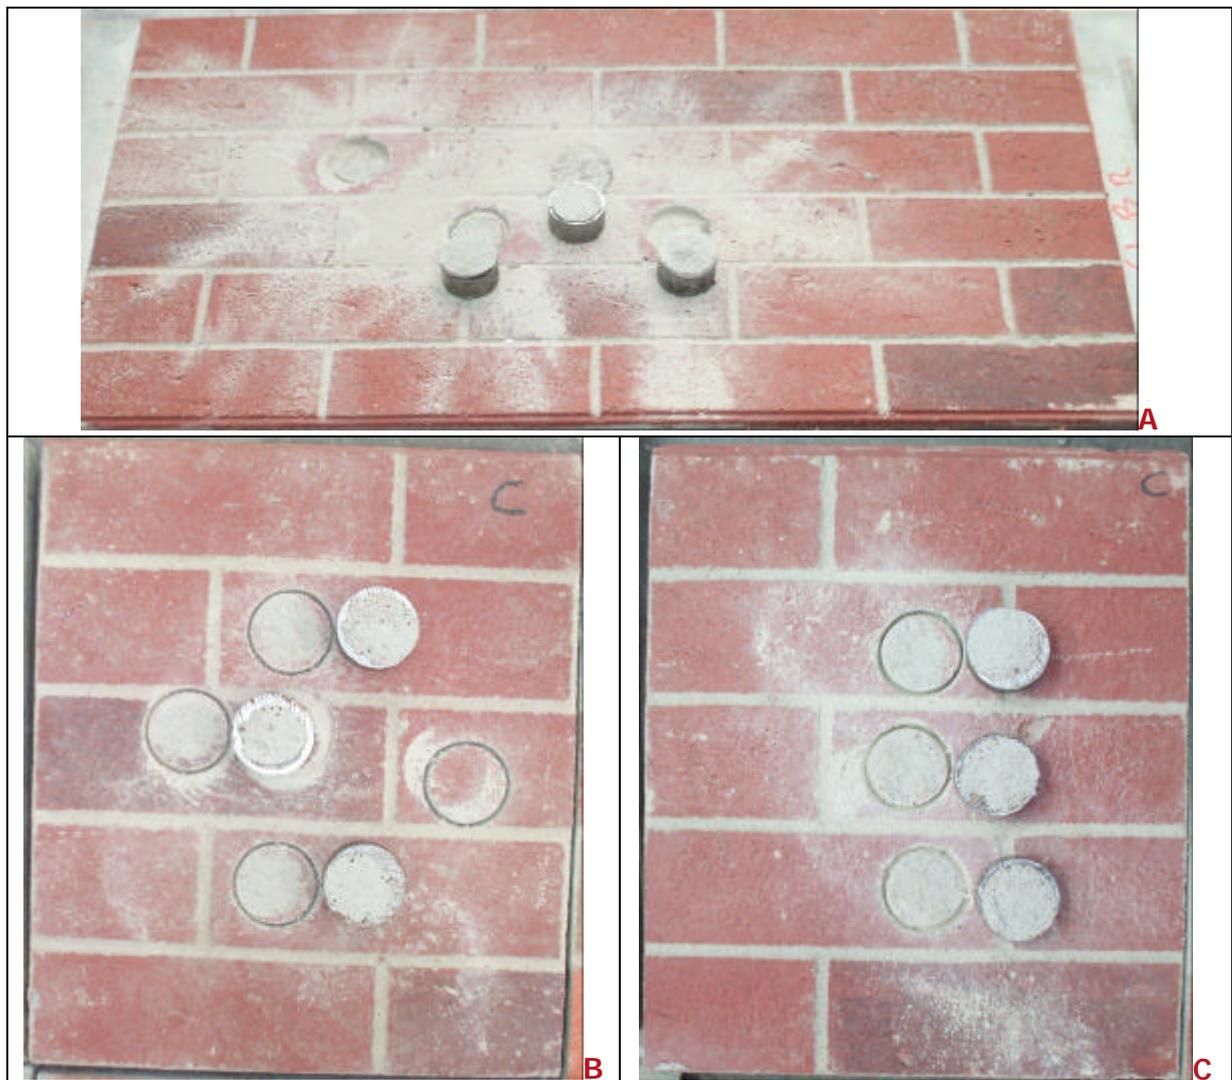
**Panel C**

Panel C Control	$F_u$ (N)	$f_u$ (N/mm <sup>2</sup> )	Fracture Pattern
1	673	0.34	100% in render
2	1108	0.56	100% in render
3	892	0.45	100% in render
<b>Mean</b>	<b>891</b>	<b>0.45</b>	<b>100% in render</b>

Panel C HP	$F_u$ (N)	$f_u$ (N/mm <sup>2</sup> )	Fracture Pattern
1	310	0.16	100% in render
2	846	0.43	100% in render
3	X	X	No adhesion
<b>Mean</b>	<b>578</b>	<b>0.30</b>	<b>100% in render</b>

Panel C F/T	$F_u$ (N)	$f_u$ (N/mm <sup>2</sup> )	Fracture Pattern
1	1901	0.97	100% in render
2	1514	0.77	100% in render
3	1116	0.57	100% in render
<b>Mean</b>	<b>1510</b>	<b>0.77</b>	<b>100% in render</b>

Pull Off Figures A – Control, B – After Hygrothermal Exposure, C – After Freeze/Thaw Exposure

Panel C, which is composed of a single render layer with a spray coat of the pigment onto the surface, shows a reduction in pull off load following hygrothermal cycling but an increased pull off load for the panel exposed to freeze-thaw cycling. The mode of failure is within the render layer in all cases, including the control panel.

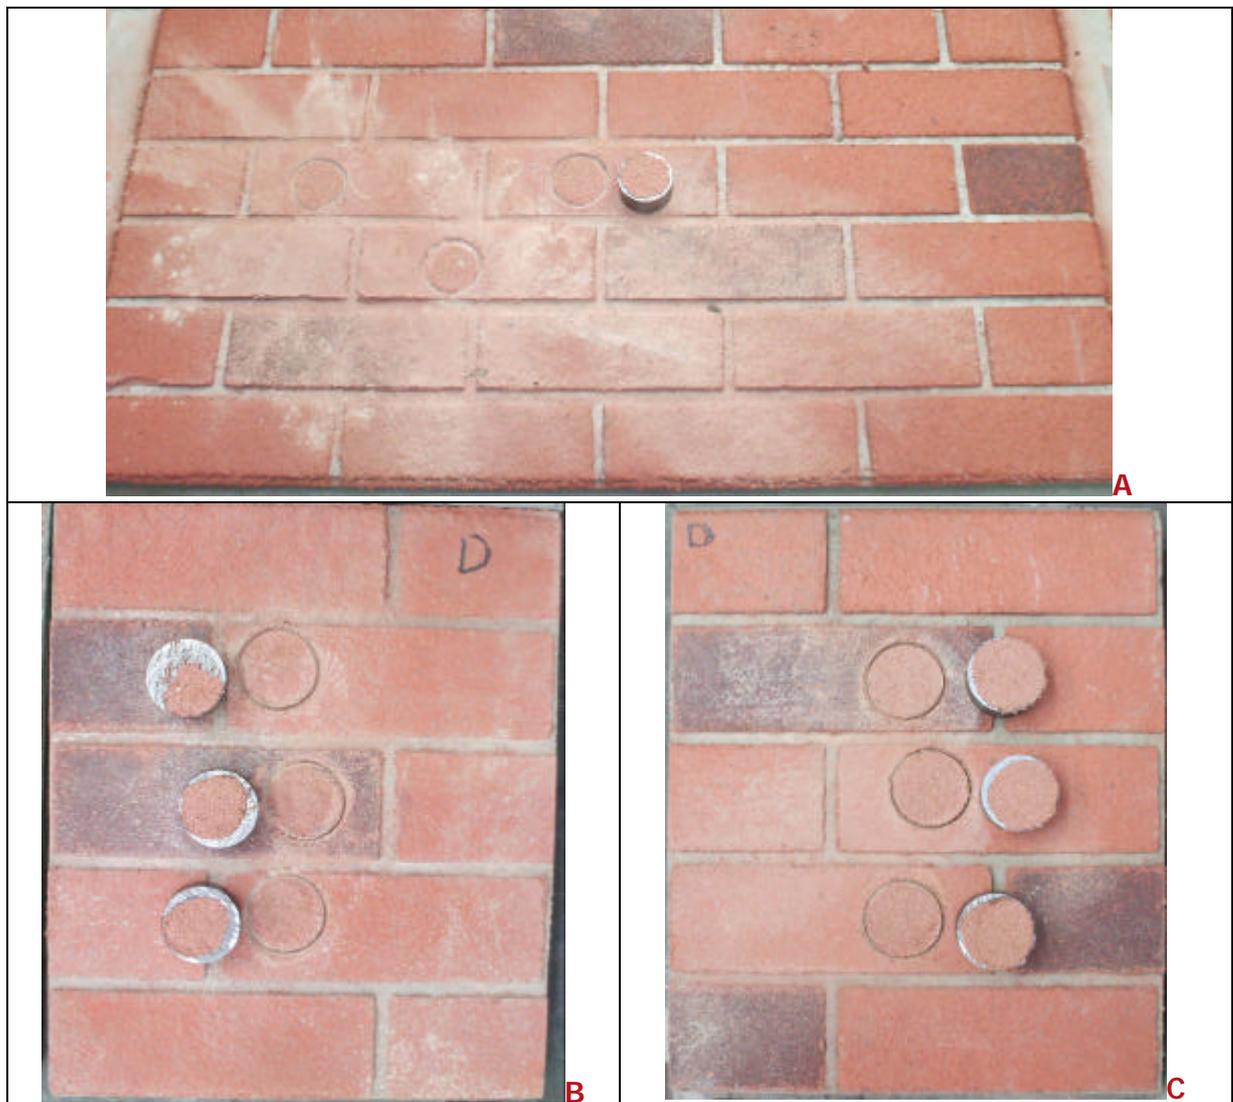
**Panel D**

Panel D Control	$F_u$ (N)	$f_u$ (N/mm <sup>2</sup> )	Fracture Pattern
1	1923	0.98	100% in pigmented layer
2	2389	1.22	100% in pigmented layer
3	1279	0.65	100% in pigmented layer
<b>Mean</b>	<b>1864</b>	<b>0.95</b>	<b>100% in pigmented layer</b>

Panel D HP	$F_u$ (N)	$f_u$ (N/mm <sup>2</sup> )	Fracture Pattern
1	2037	1.04	100% failure in pigmented layer
2	2368	1.21	100% failure in pigmented layer
3	1150	0.59	50% failure in pigmented layer
<b>Mean</b>	<b>1852</b>	<b>0.95</b>	<b>+50% failure in pigmented layer</b>

Panel D F/T	$F_u$ (N)	$f_u$ (N/mm <sup>2</sup> )	Fracture Pattern
1	2064	1.05	100% failure in pigmented layer
2	2646	1.35	100% failure in pigmented layer
3	3152	1.61	100% failure in pigmented layer
<b>Mean</b>	<b>2621</b>	<b>1.34</b>	<b>100% failure in pigmented layer</b>

Pull Off Figures A – Control, B – After Hygrothermal Exposure, C – After Freeze/Thaw Exposure

Panel D, the single pigmented spray coat of render onto the concrete base, has shown very good over all performance. The pull off values for both the hygrothermal panel and the freeze-thaw panel are the same (hygrothermal) or greater (F-T) than the control. This again indicates that the exposure has resulted in a continuation of the strength development over time of the render.

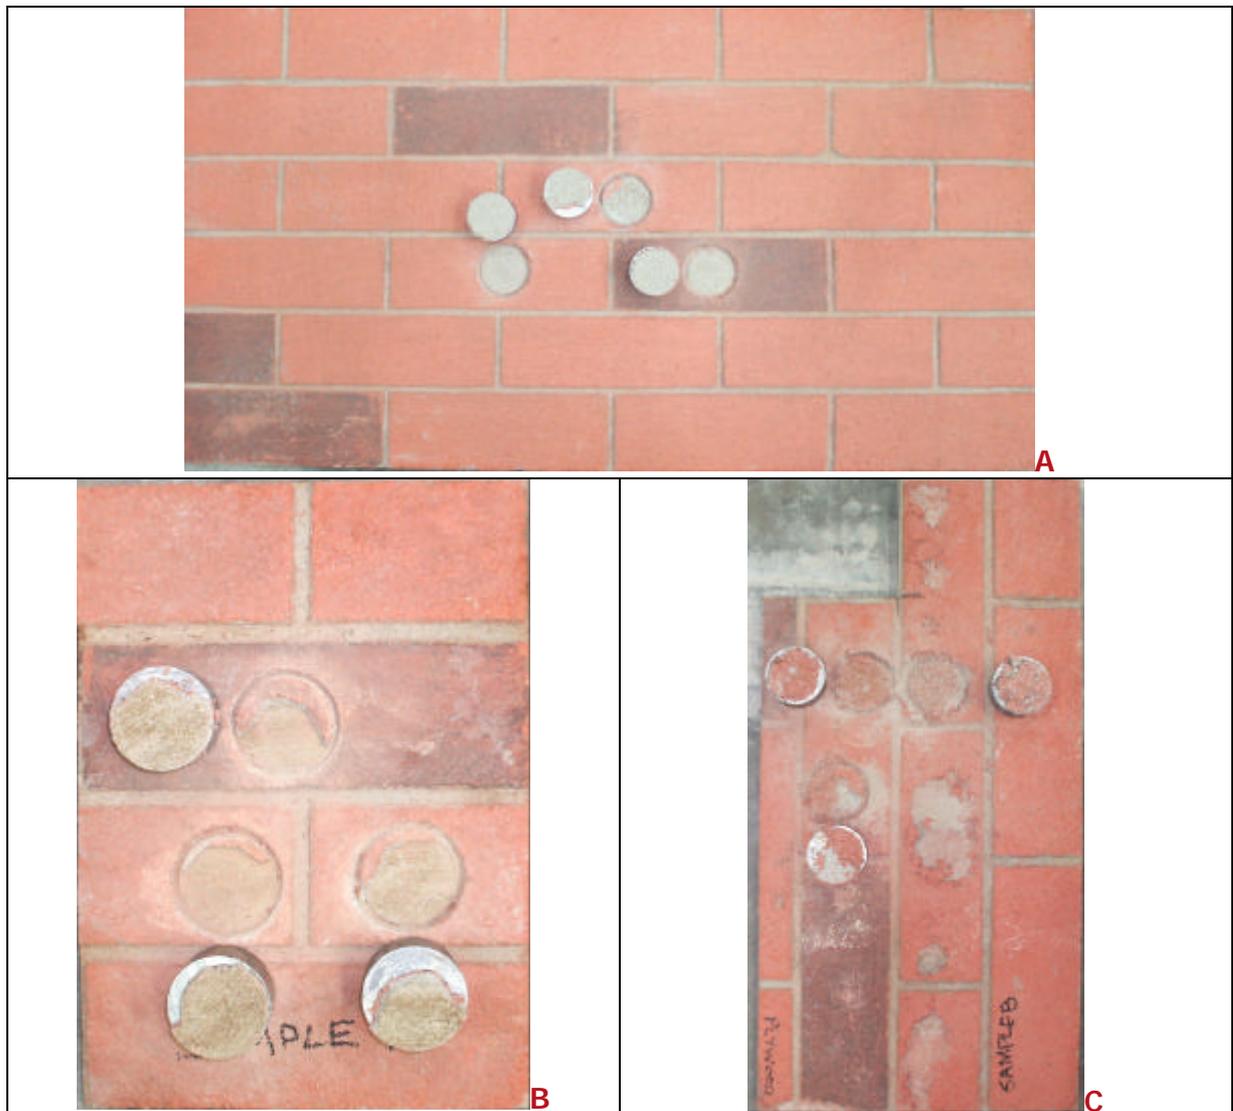
**Plywood**

Plywood Control	$F_u$ (N)	$f_u$ (N/mm <sup>2</sup> )	Fracture Pattern
1	400	0.20	90% failure in base coat
2	404	0.21	90% failure in base coat
3	280	0.14	90% failure in base coat
Mean	361	0.18	90% failure in base coat

Plywood HP	$F_u$ (N)	$f_u$ (N/mm <sup>2</sup> )	Fracture Pattern
1	750	0.38	90% loss of adhesion to base
2	617	0.31	100% loss of adhesion to base
3	513	0.26	100% loss of adhesion to base
Mean	627	0.32	+90% loss of adhesion to base

Plywood F/T	$F_u$ (N)	$f_u$ (N/mm <sup>2</sup> )	Fracture Pattern
1	X	X	No adhesion frost damage to top layer
2	52	0.03	Poor very weak bond to top layer
3	X	X	No adhesion frost damage to top layer
Mean	52	0.03	Poor very weak bond to top layer

Pull Off Figures A – Control, B – After Hygrothermal Exposure, C – After Freeze/Thaw Exposure

The Plywood panel were by far the system that showed significant signs of deterioration with exposure to the freeze-thaw cycling. It is therefore not surprising that the results of the pull off tests show that the required force to pull the discs off has been dramatically reduced. The hygrothermal panels however have increased in pull of resistance. Again the issue of the time of testing in relation to the curing period may be a significant factor in these results. The freeze-thaw exposure will have dramatically weakened the render, whilst the hygrothermal exposure may well have resulted in the continuation of curing.
